# PRODUCT OUTGOING INSPECTION REPORT

## HORUS420-R1

Revision Date: February 19, 2024

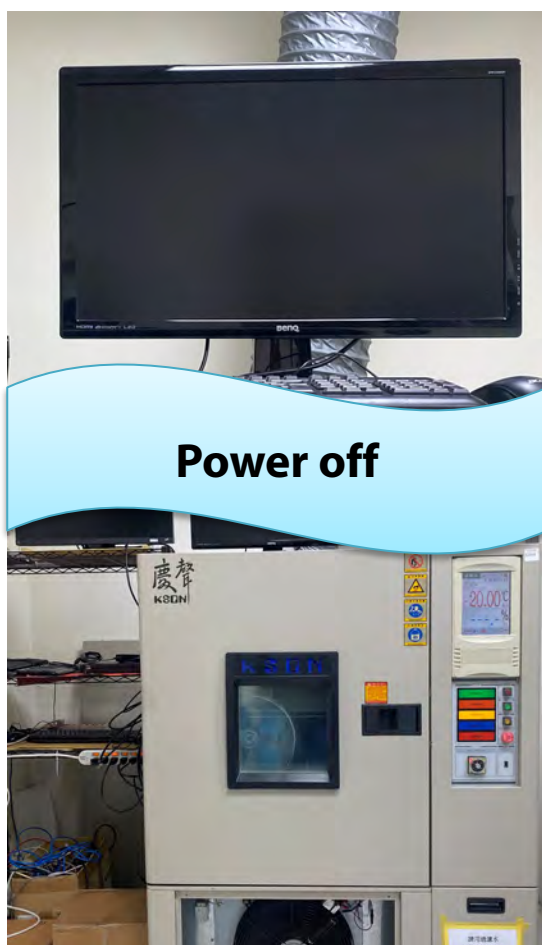
### 2-2-3. LOW-TEMPERATURE & BOOT-UP

#Power supply under -20°C and ensure that the system boot up properly

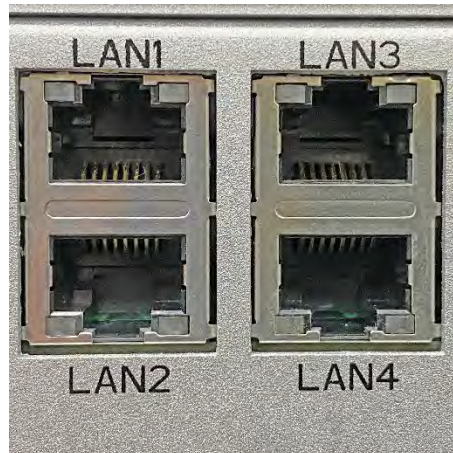
### 5-3. LAN 1G

| Item | Test Criteria | Result |
|---|---|---|
| <b>LAN</b><br>( 3x Intel® i210IT ) | Connection 1G/10G/100G SWITCH HUB transfer data test, it can work normally. | PASS |
| <b>LAN</b><br>( 1x Intel® i219LM ) | Connection 1G/10G/100G SWITCH HUB transfer data test, it can work normally. | PASS |

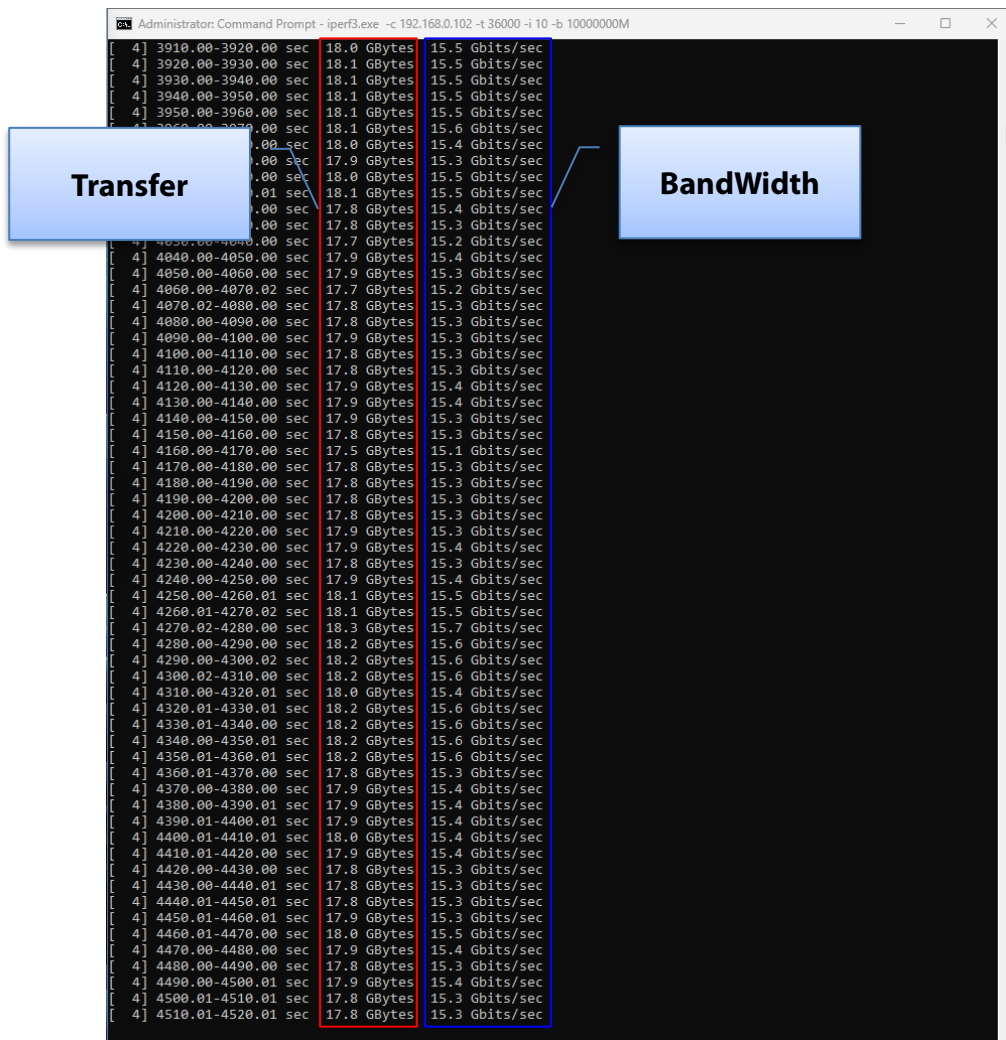
### 5-4. LAN 10G

| Item | Test Criteria | Result |
|---|---|---|
| <b>LAN</b><br>( 2x Intel® 82599ES [10GbE] ) | Connection 1G/10G/100G SWITCH HUB transfer data test, it can work normally. | PASS |
