# PRODUCT OUTGOING QUALITY INSPECTION REPORT

## SCH-202

Revision Date: July 15, 2024

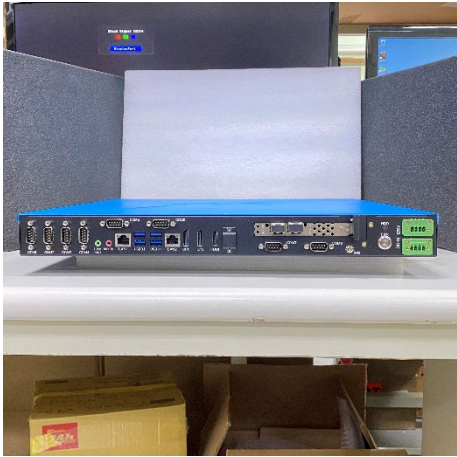
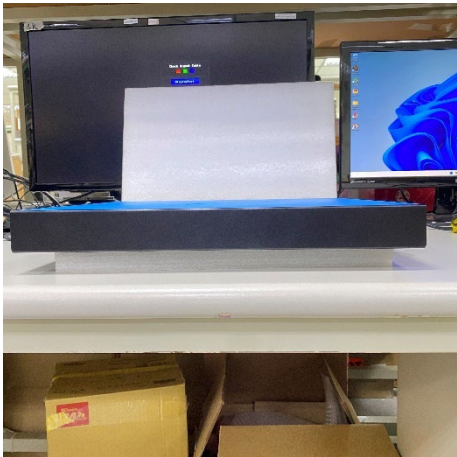
| Cosmetic Inspection Photo | |
|---|---|
| FRONT SIDE | BACK SIDE |

| No. | Result | | | Inspection items | Remark |
|---|---|---|---|---|---|
| 1 | ✓ | | | Whether there are Scratch mark on the appearance? | |
| 3 | ✓ | | | Whether there are impact scars on the appearance? | |
| 5 | ✓ | | | Whether there is a deformation in the appearance? | |
