**Report No.: VS-TV-1130305-06**

# Test Report

**Specimen: AV400-T4**  
**Applicant Name : PERFECTRON CO., LTD. TAIWAN BRANCH (B.V.I)**  
**Applicant Address : 2 F., No. 190, Sec. 2, Zhongxing Rd., Xindian Dist.,  
New Taipei City 23146, Taiwan**

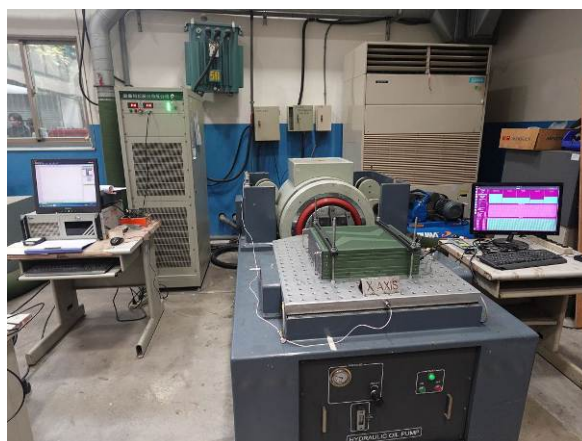
FIG 1.1 : X Axis direction mounted

FIG 1.2 : X Axis direction mounted

| Test Item | Test 1 : Vibration Test | | |
|---|---|---|---|
| | FIG 1.1 ~ 1.2: | X axis direction mounted | |

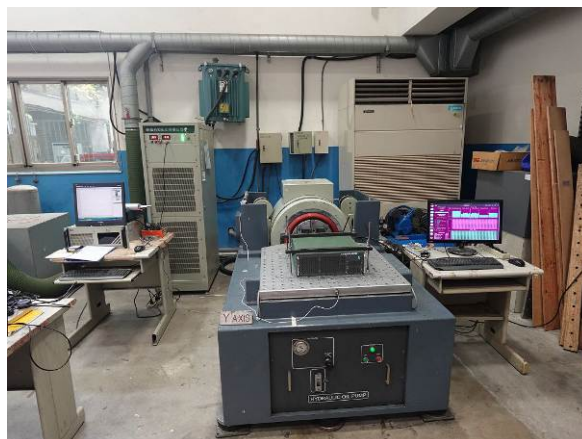
FIG 3.1 : Y Axis direction mounted

FIG 3.2 : Y Axis direction mounted

| Test Item | Test 1 : Vibration Test | | |
|---|---|---|---|
| | FIG 3.1 ~ 3.2: | Y axis direction mounted | |

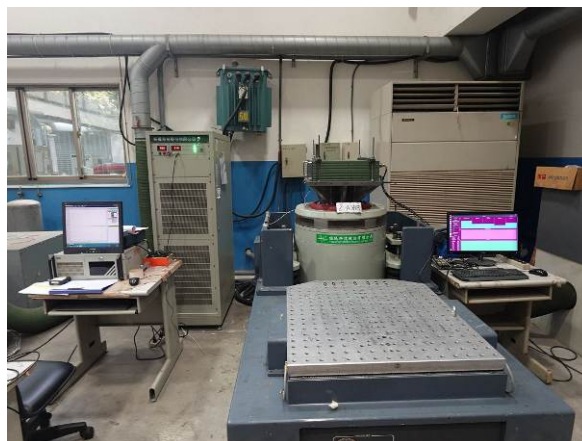
FIG 5.1 : Z Axis direction mounted

FIG 5.2 : Z Axis direction mounted

| Test Item | Test 1 : Vibration Test | | |
|---|---|---|---|
| | FIG 5.1 ~ 5.2: | Z axis direction mounted | |

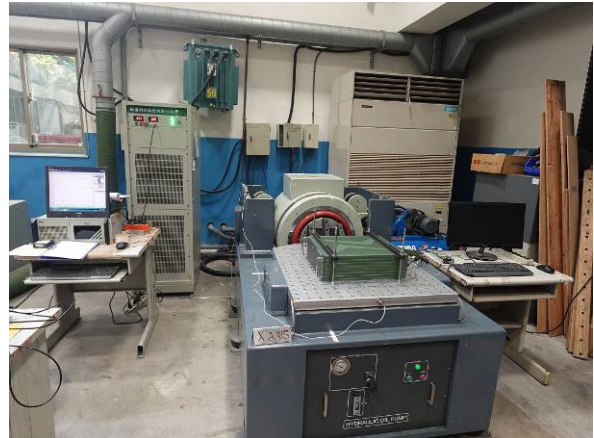
FIG 7.1 : X Axis direction mounted

FIG 7.2 : X Axis direction mounted

| Test Item | Test 2 : Vibration Test | | |
|---|---|---|---|
| | FIG 7.1 ~ 7.2: | X axis direction mounted | |

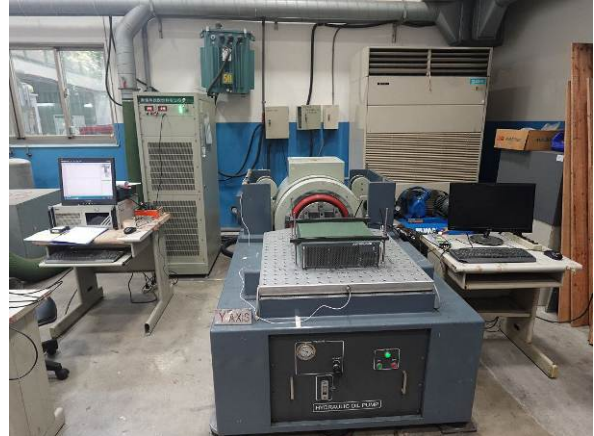
FIG 9.1 : Y Axis direction mounted

FIG 9.2 : Y Axis direction mounted

| Test Item | Test 2 : Vibration Test | | |
|---|---|---|---|
| | FIG 9.1 ~ 9.2: | Y axis direction mounted | |

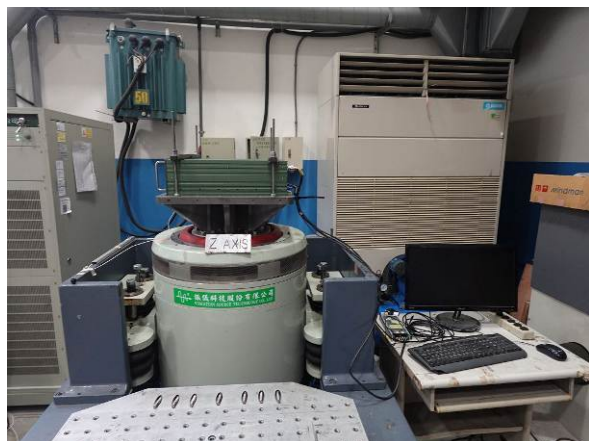
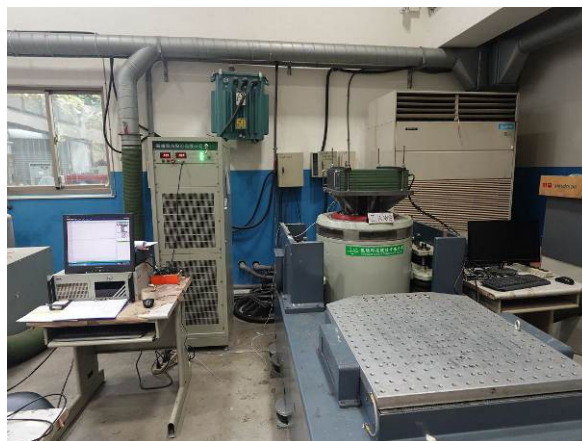
FIG 11.1 : Z Axis direction mounted

FIG 11.2 : Z Axis direction mounted

| Test Item | Test 2 : Vibration Test | | |
|---|---|---|---|
| | FIG 11.1 ~ 11.2: | Z axis direction mounted | |

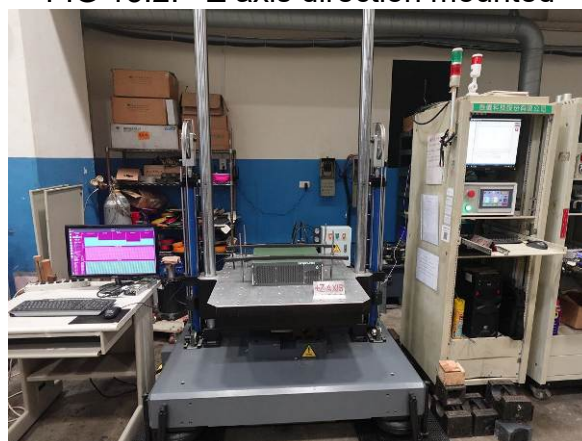
FIG 13.1: +Z axis direction mounted

FIG 13.2: +Z axis direction mounted

| Test Item | Test 3 : Shock Test |
|---|---|
| Test Condition | <p>Waveform: Half Sine Wave</p> <p>Shock Peak Acceleration: 20 G</p> <p>Duration Time: 11 ms</p> <p>Shock Axial: <math>\pm Z</math> Axis</p> <p>Shock Time: 1 time</p> <p>Total Time: 2 times</p> <p>FIG 13.1 ~ 13.2: +Z axis direction mounted</p> <p>FIG 14: +Zaxis test screen</p> <p>FIG 15.1 ~ 15.2: -Z axis direction mounted</p> <p>FIG 16: -Z axis test screen</p> |

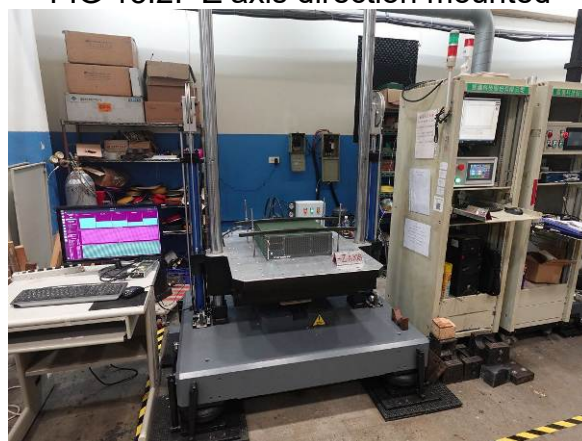
FIG 15.1: -Z axis direction mounted

FIG 15.2: -Z axis direction mounted

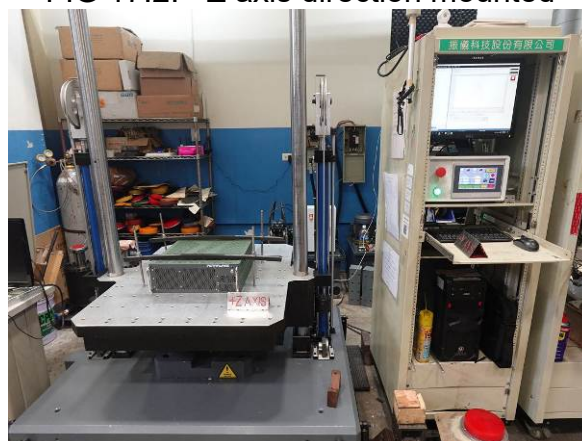
FIG 17.1: +Z axis direction mounted

FIG 17.2: +Z axis direction mounted

| Test Item | Test 3 : Shock Test |
|---|---|
| Test Condition | <p>Waveform: Half Sine Wave</p> <p>Shock Peak Acceleration: 40 G</p> <p>Duration Time: 11 ms</p> <p>Shock Axial: <math>\pm Z</math> Axis</p> <p>Shock Time: 1 time</p> <p>Total Time: 2 times</p> <p>FIG 17.1 ~ 17.2: +Z axis direction mounted</p> <p>FIG 18: +Zaxis test screen</p> <p>FIG 19.1 ~ 19.2: -Z axis direction mounted</p> <p>FIG 20: -Z axis test screen</p> <p>Posterior check photos</p> |

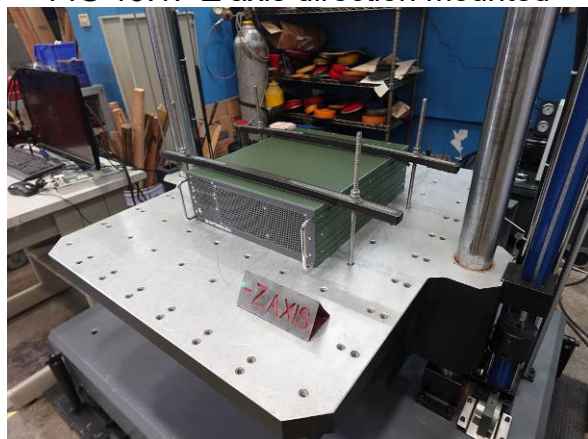
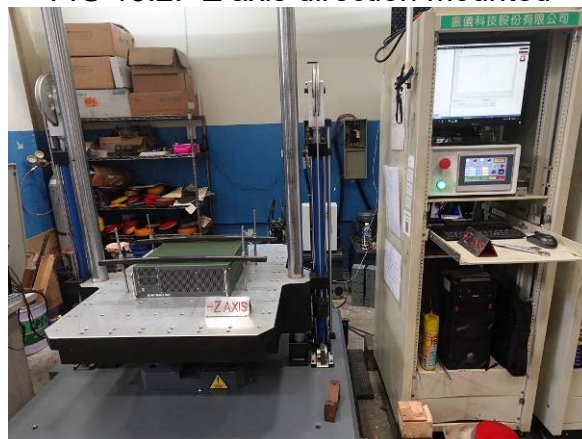
FIG 19.1: -Z axis direction mounted

FIG 19.2: -Z axis direction mounted

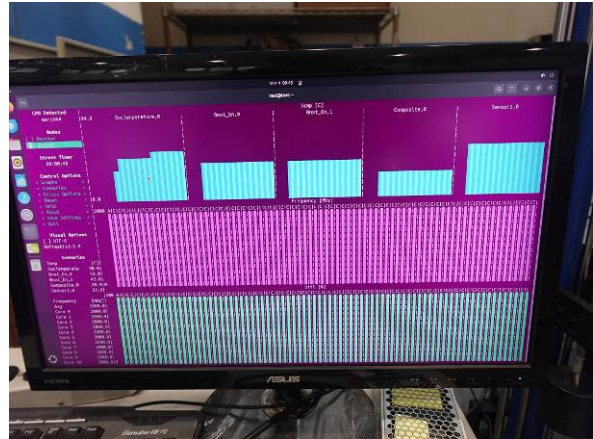
Posterior check photos

| Test Result | Appearance: No external physical damage.<br>Function: Upon Applicant's comment. | |
