Applicant : 7Starlake Co., LTD.  
2F., No.190, Sec. 2, Zhongxing Rd., Xindian Dist.,  
New Taipei City 23146, Taiwan (R.O.C.)

Description : Sample Name AV800-S4L4  
Model Name AV800-S4L4  
Date of Received OCT. 22, 2025  
Date of Testing OCT. 23, 2025 ~ NOV. 18, 2025

## Conclusion

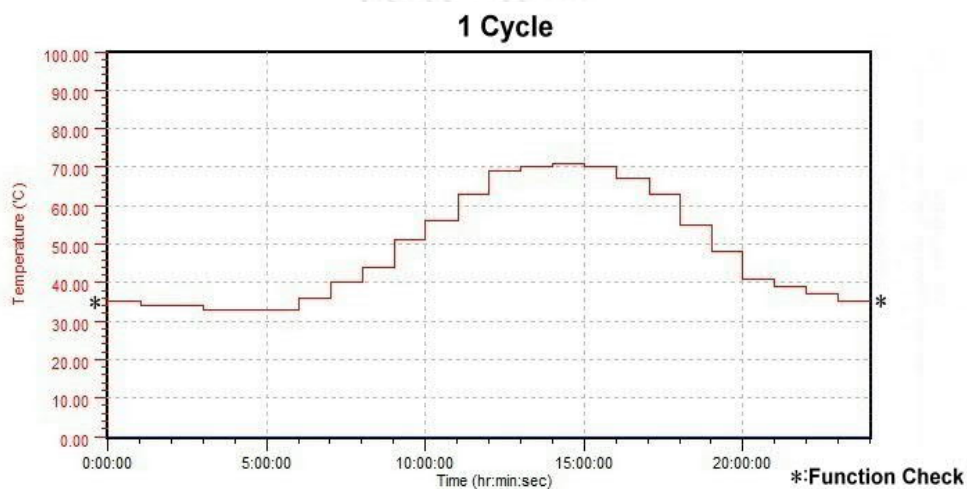
Test Condition :

The test was performed with reference to MIL-STD-810H method 501.7 procedure I and customer specification.
