## TEST REPORT

Vibration Test

Temperature Cycle Test

251200166TPE-001

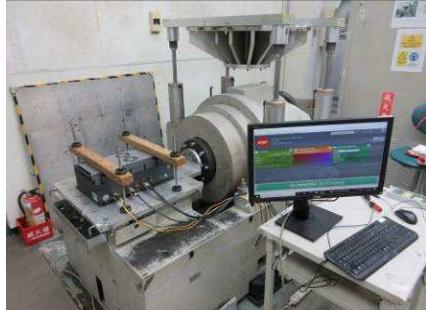
X axis

### -Setup photo:

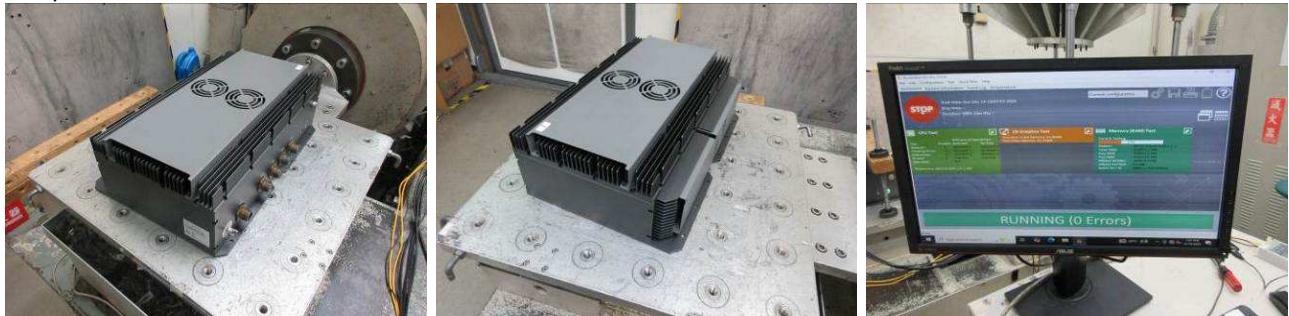
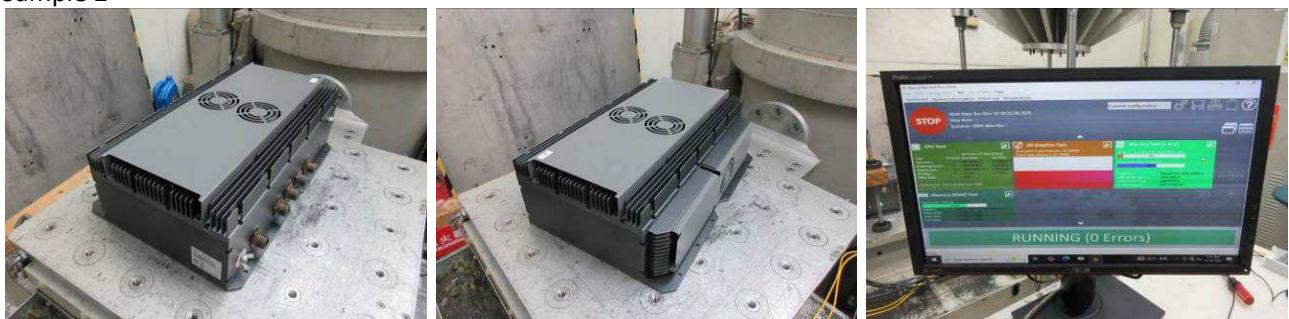
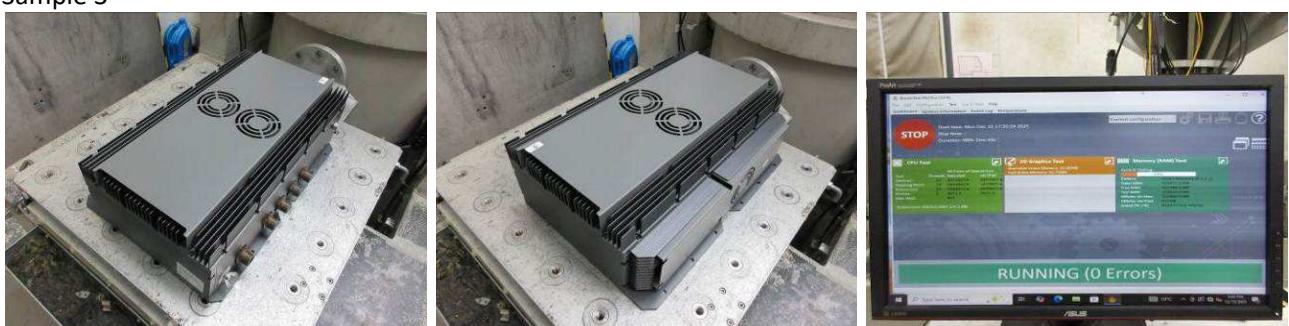
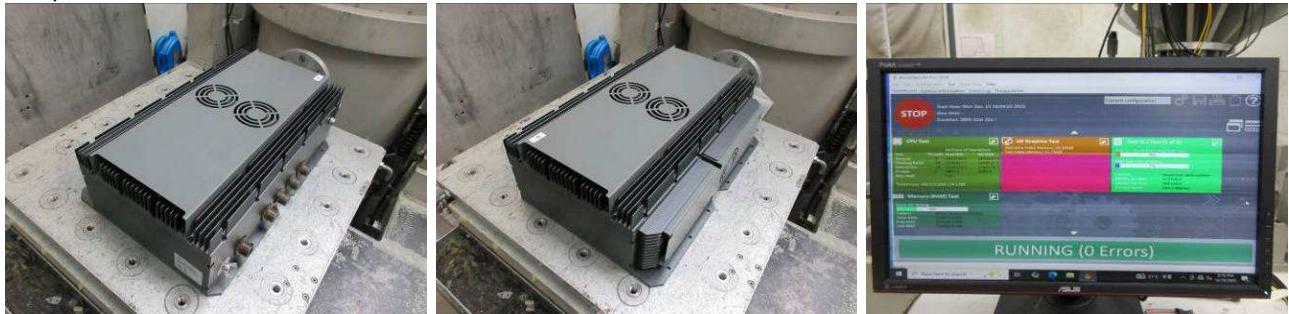
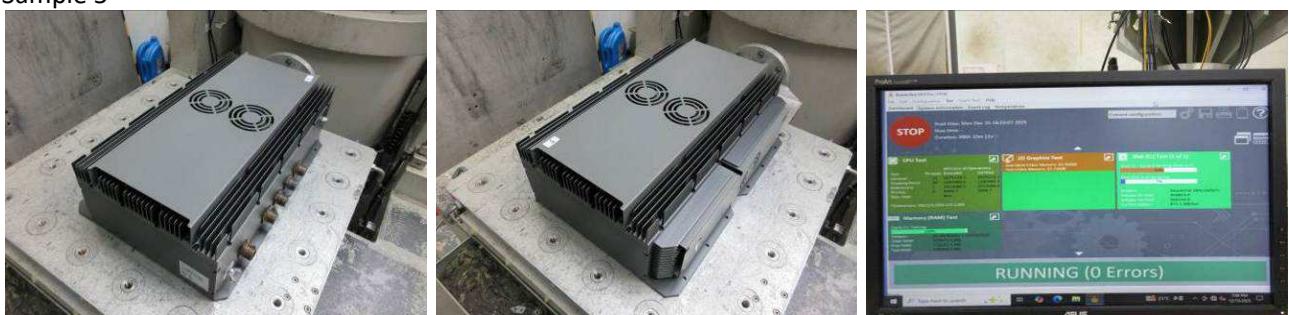
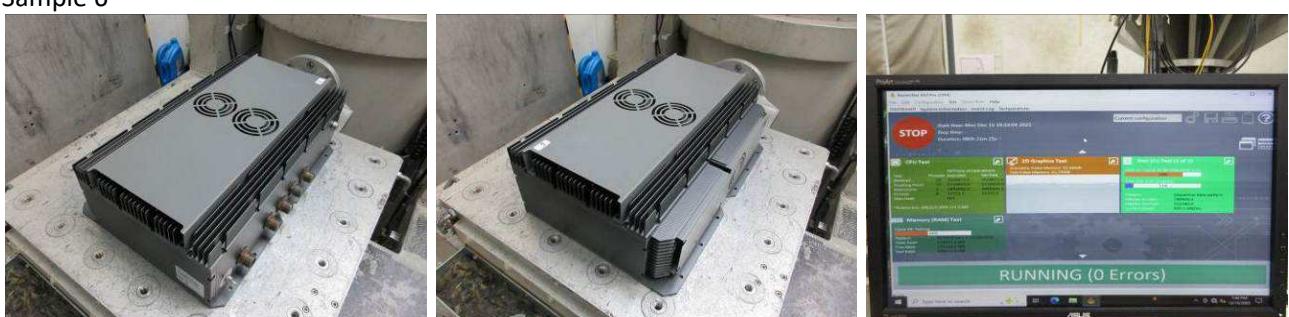
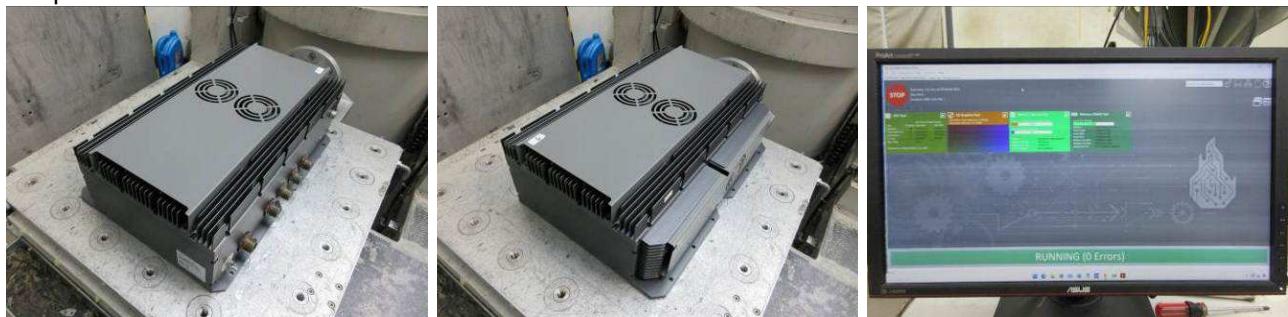
-No visible damage was found on sample appearance after the test.

-Sample photo after the test:

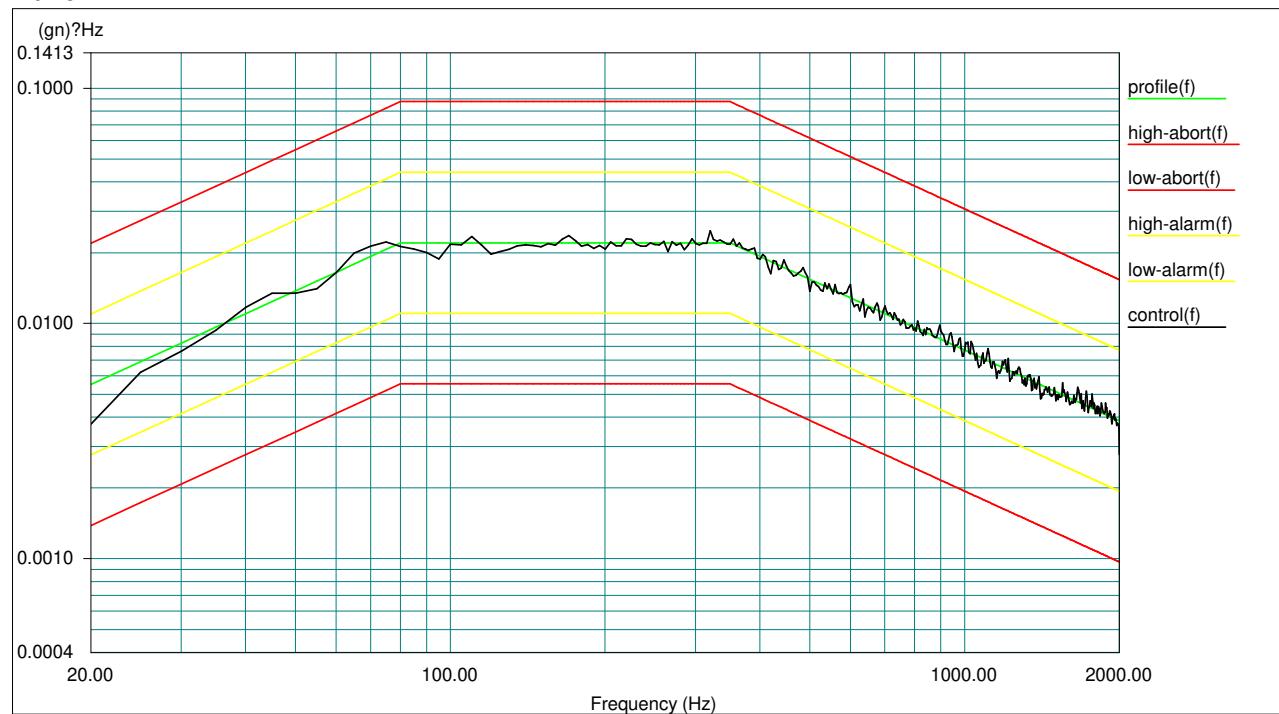
X axis

-Test profile:

Control RMS: 4.494551 gn

Full Level Elapsed Time: 00:10:00

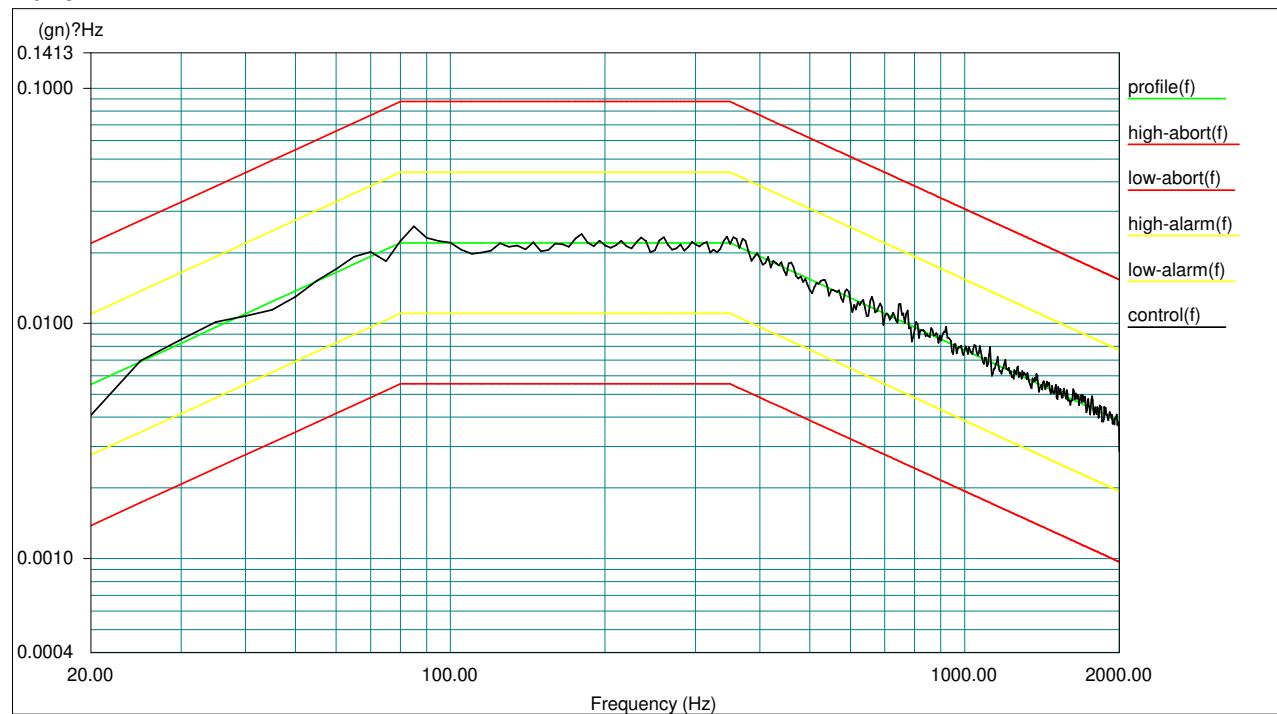
Y axis

-Test profile:

Control RMS: 4.493557 gn

Full Level Elapsed Time: 00:10:00

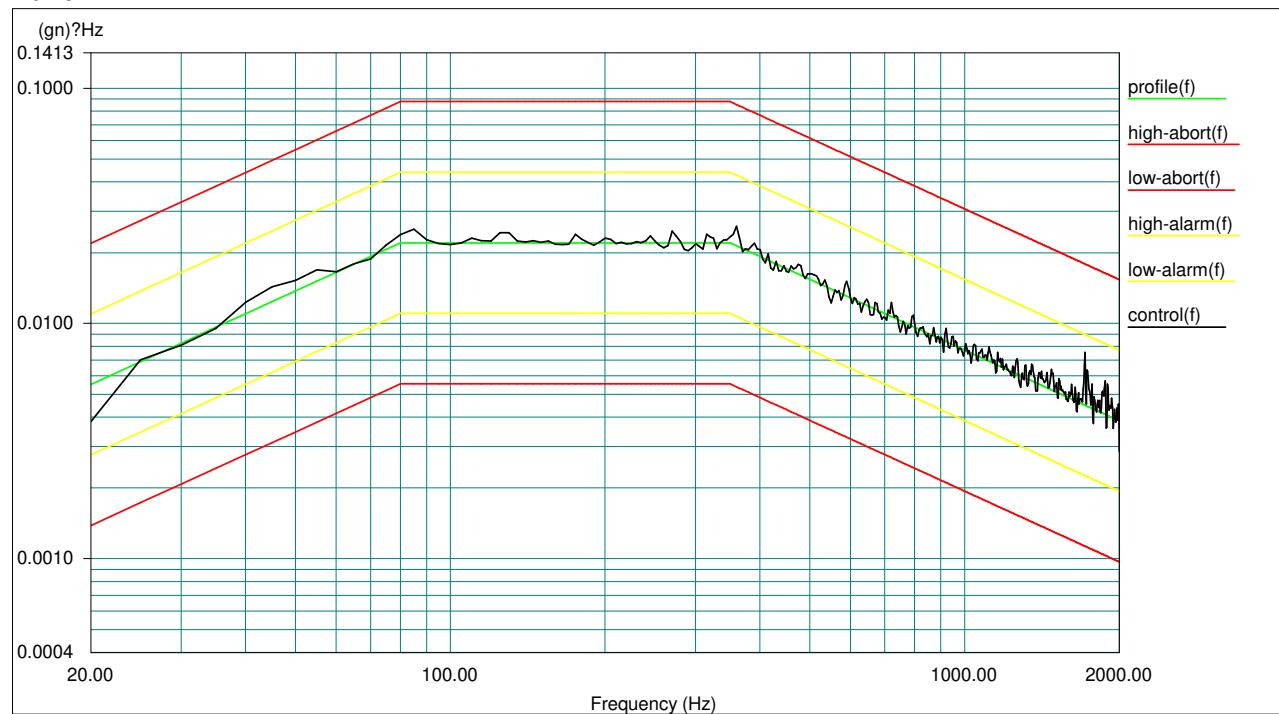
Z axis

-Test profile:

Control RMS: 4.587714 gn

Full Level Elapsed Time: 00:10:00

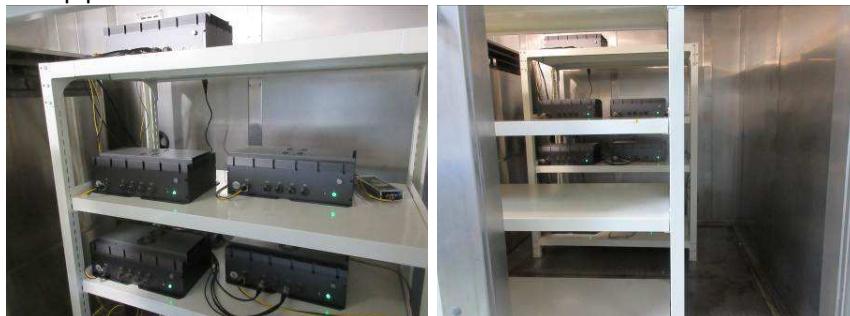
-Setup photo:

- Testing temperature: -15 °C and 63 °C
- Duration at each severe condition: 30 minutes
- Number of cycle: 10 cycles
- First and last cycles should be done with power on as such:  
Lower temp to -15C, and after stabilizing at -15C for 30 mins, run ATP.  
Raise temp to +63C and after stabilizing at +63C for 30 mins, run ATP.

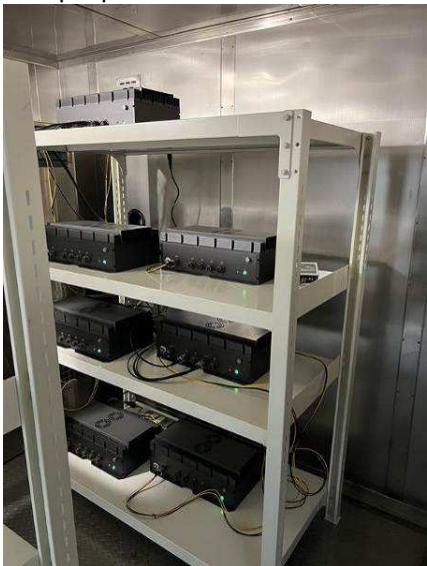
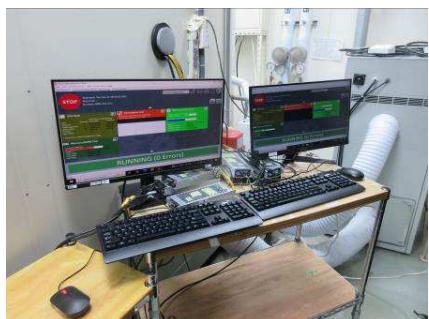
- No visible damage was found on sample appearance after the test.
- All ATP functional tests running normally.
- Sample photo after the test:
